**Flood Control Project Maintenance
Levee Inspections**
LMA District Cover Sheet
Spring 2019 Levee Inspection Results

Reclamation District No. 0307 Lisbon

Spring 2019 Levee Inspection Results

Waterway			Bank	Unit Miles
Unit No. 01 Sacramento River			Right	6.56
	Spring (March - May)	Summer (June - August)	(September - November) Fall	Winter (December - February)
Unit Maintenance Rating (Fall Only)				
Date of Inspection	3/8/2019 - 3/8/2019			
DWR Inspector	Luz Dial			
Accompanied By	Pete Dwyer RD 307

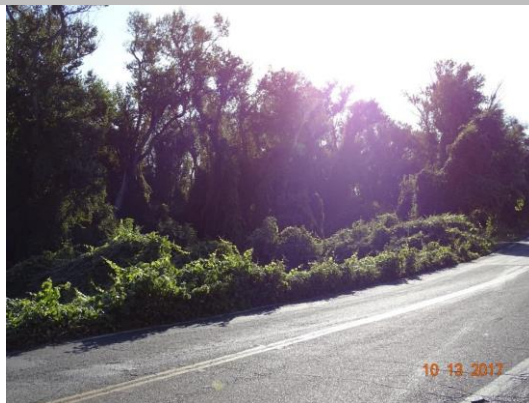
Photo 1 of 1 : SP_2019_RD0307_166_60_20190307_00014.jpg

LM Start	0.10	Rating **	M	Issue No.	60
LM End	0.23	Issue Type +	Ma	Location *	WS
Category	Earthen Levee			GPS Latitude/Longitude	
				Start	End
Item	Vegetation			38.478937 °	38.477725 °
				-121.548172 °	-121.546511 °
DWR ID	DWR_RD0307_01_f_2017_60				
Comment Code					
V2 : Remove the wild growth other than native grasses from the levee slopes.					
Inspector Comment

Waterside vegetation should be trimmed to 20 feet from crown to allow inspection. Fall 2017

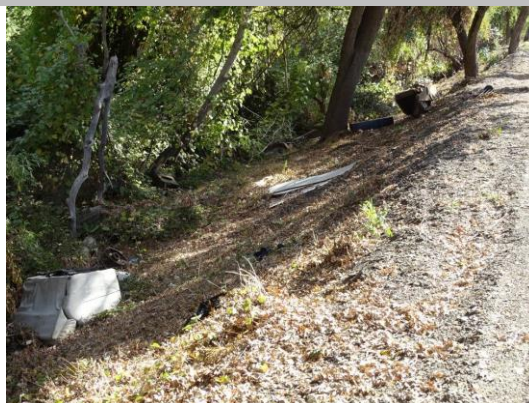
Photo 1 of 2 : SP_2019_RD0307_166_129_20190307_00039.jpg

LM Start	0.14	Rating **	M	Issue No.	129
LM End	0.14	Issue Type +	Ma	Location *	WS
Category	Earthen Levee			GPS Latitude/Longitude	
				Start	End
Item	Encroachments			38.478536 °	38.478536 °
				-121.547707 °	-121.547707 °
DWR ID	DWR_RD0307_01_f_2018_129				
Comment Code					
DE : Debris					
Inspector Comment					
Remove trash from slope.

View of sofa thrown on slope. Fall 2018

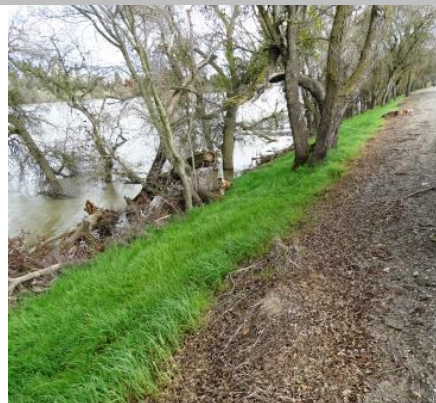
Photo 1 of 1 : SP_2019_RD0307_166_159_20190312_00136.jpg

LM Start	0.55	Rating **	M	Issue No.	159
LM End	0.55	Issue Type +	Ma	Location *	WS
Category	Earthen Levee			GPS Latitude/Longitude	
				Start	End
Item	Encroachments			38.474753 °	38.474753 °
				-121.541970 °	-121.541970 °
DWR ID	DWR_RD0307_01_s_2019_159				
Comment Code					
TR : Tree or limb					
Inspector Comment					
Fallen tree needs to be removed from levee slope.

View of fallen tree on levee slope. Spring 2019

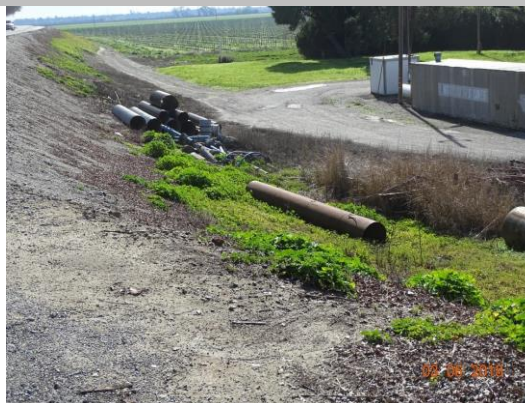
Photo 1 of 1 : SP_2019_RD0307_166_48_20190307_00007.jpg

LM Start	0.58	Rating **	M	Issue No.	48
LM End	0.58	Issue Type +	En	Location *	LS
Category	Earthen Levee			GPS Latitude/Longitude	
				Start	End
Item	Encroachments			38.474543 °	38.474543 °
				-121.541419 °	-121.541419 °
DWR ID	DWR_RD0307_01_s_2018_48				
Comment Code					
EQ : Equipment					
Inspector Comment					
Pipes stored at landside toe need to be removed.

View looking southeast at encroachment pipes on landside toe. Spring 2018

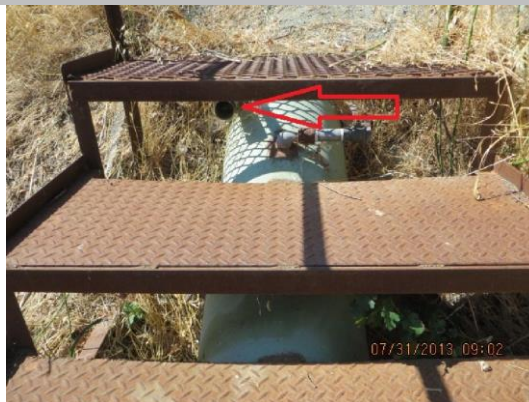
Photo 3 of 3 : UCIP_SP_2019_17103_29200.jpg

LM Start	0.93	Rating **	M	Issue No.	162 (cont)
LM End	0.93	Issue Type +	En	Location *

Conduit visible under first step of walkway to pump on WS shoulder.

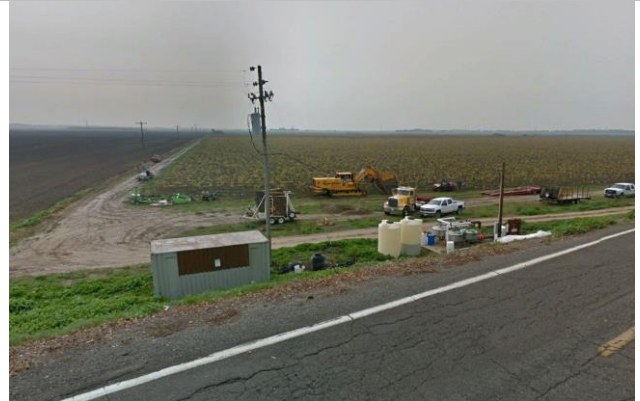
Photo 1 of 1 : SP_2019_RD0307_166_81_20190307_00022.jpg

LM Start	0.94	Rating **	U	Issue No.	81
LM End	0.94	Issue Type +	En	Location *	LS
Category	Earthen Levee			GPS Latitude/Longitude	
				Start	End
Item	Encroachments			38.472838 °	38.472838 °
				-121.535327 °	-121.535327 °
DWR ID	DWR_RD0307_01_f_2017_81				
Comment Code					
EQ : Equipment					
Inspector Comment					
Remove shed and equipment from landside levee toe and 10-foot easement.

10/13/2017: Remove shed and equipment from levee toe and 10-foot easement.

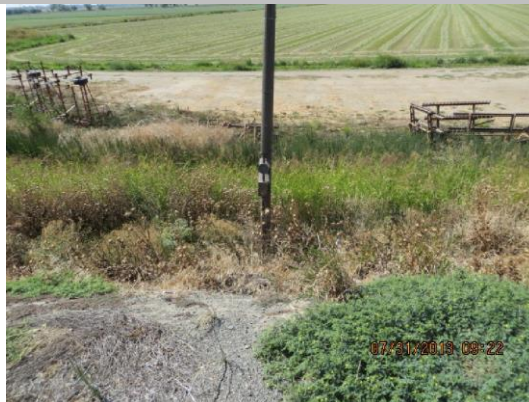
Photo 3 of 3 : UCIP_SP_2019_16766_28770.jpg

LM Start	1.08	Rating **	M	Issue No.	164 (cont)
LM End	1.08	Issue Type +	En	Location *

Conduit visible at base of JP on LS toe.

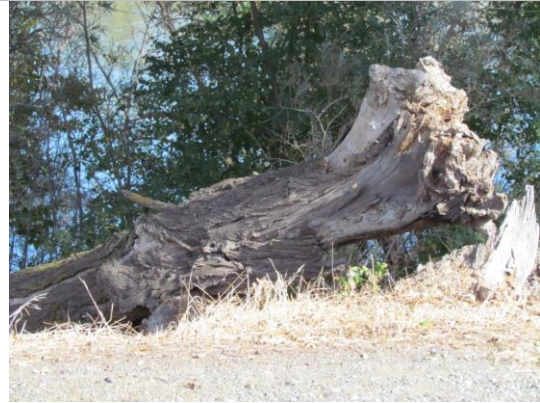
Photo 1 of 1 : SP_2019_RD0307_166_9_20190307_00001.jpg

LM Start	1.29	Rating **	U	Issue No.	9
LM End	1.29	Issue Type +	Ma	Location *	WS
Category	Earthen Levee			GPS Latitude/Longitude	
				Start	End
Item	Encroachments			38.472827 °	38.472827 °
				-121.528785 °	-121.528785 °
DWR ID	DWR_RD0307_01_f_2014_9				
Comment Code					
TR : Tree or limb					
Inspector Comment					
Remove fallen trees from waterside slope.

This tree needs to be removed from the waterside slope. Fall 2018

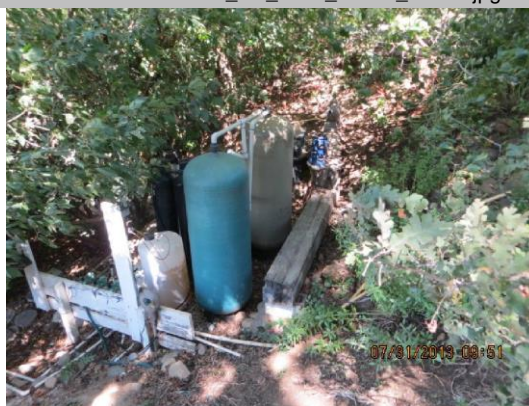
Photo 1 of 3 : UCIP_SP_2019_17106_29210.jpg

LM Start	1.62	Rating **	M	Issue No.	166 (cont)
LM End	1.62	Issue Type +	En	Location *

Possible pump and filter plant on LS slope.

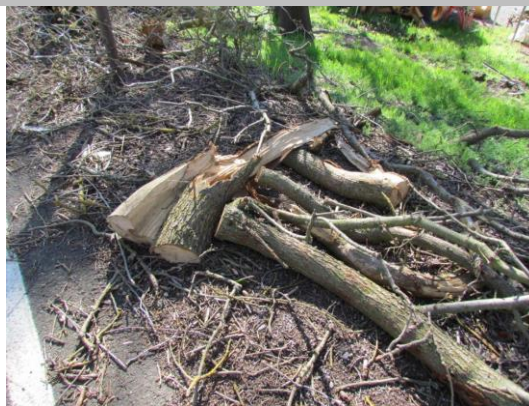
Photo 1 of 3 : SP_2019_RD0307_166_73_20190307_00017.jpg

LM Start	1.86	Rating **	U	Issue No.	73
LM End	1.86	Issue Type +	Ma	Location *	LS
Category	Earthen Levee			GPS Latitude/Longitude	
				Start	End
Item	Encroachments			38.473182 °	38.473182 °
				-121.518280 °	-121.518280 °
DWR ID	DWR_RD0307_01_s_2016_73				
Comment Code					
TR : Tree or limb					
Inspector Comment					
Remove the cut-up oak tree from both ls/ws slopes of the levee section.

Looking downstream from levee mile 1.86 cut up fallen tree on shoulder.

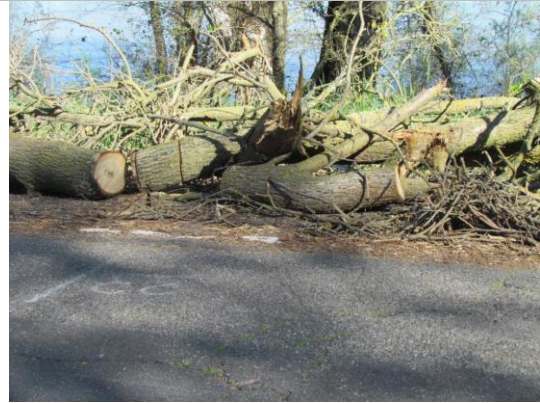
Photo 3 of 3 : SP_2019_RD0307_166_73_20190307_00019.jpg

LM Start	1.86	Rating **	U	Issue No.	73 (cont)	
LM End	1.86	Issue Type +	Ma	Location *	LS	
Category	Earthen Levee			GPS Latitude/Longitude		
				Start	End	
Item	Encroachments			38.473182 °	38.473182 °	
				-121.518280 °	-121.518280 °	
DWR ID	DWR_RD0307_01_s_2016_73					
Comment Code						
TR : Tree or limb						
Inspector Comment						
Remove the cut-up oak tree from both ls/ws slopes of the levee section.

Waterside shoulder levee mile 1.86 more of the cut up oak.

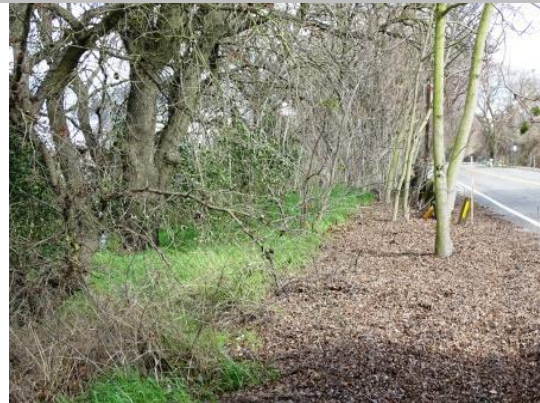
Photo 1 of 1 : SP_2019_RD0307_166_151_20190312_00134.jpg

LM Start	1.93	Rating **	M	Issue No.	151
LM End	1.94	Issue Type +	Ma	Location *	WS
Category	Earthen Levee			GPS Latitude/Longitude	
				Start	End
Item	Trim / Thin Trees			38.473117 °	38.473103 °
				-121.516990 °	-121.516820 °
DWR ID	DWR_RD0307_01_s_2019_151				
Comment Code					
T3 : Trim and thin trees to allow visibility of the ground and room to flood fight.					
Inspector Comment					
Trim trees/brush on levee slope.

View of dense trees/brush on levee slope. Spring 2019

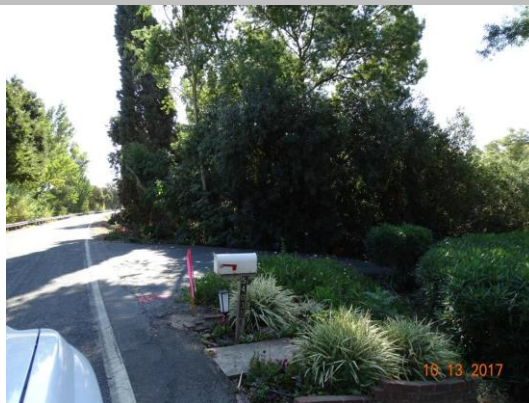
Photo 1 of 1 : SP_2019_RD0307_166_94_20190307_00025.jpg

LM Start	2.38	Rating **	M	Issue No.	94
LM End	2.41	Issue Type +	En	Location *	LS
Category	Earthen Levee			GPS Latitude/Longitude	
				Start	End
Item	Vegetation			38.471370 °	38.471137 °
				-121.509104 °	-121.508544 °
DWR ID	DWR_RD0307_01_f_2017_94				
Comment Code					
V6 : Landscaping					
Inspector Comment					
Oleanders were trimmed, but the base needs to be thinned for visual inspection.

Remove or thin oleanders to allow inspection and access. Fall 2017

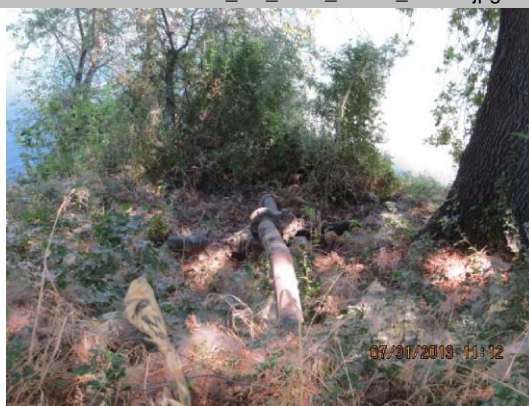
Photo 1 of 3 : UCIP_SP_2019_40794_28823.jpg

LM Start	2.42	Rating **	M	Issue No.	169 (cont)
LM End	2.42	Issue Type +	En	Location *

Pump and gate valve on WS slope.

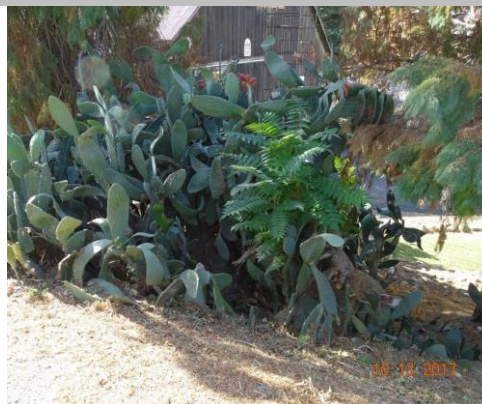
Photo 1 of 1 : SP_2019_RD0307_166_95_20190307_00026.jpg

LM Start	2.42	Rating **	U	Issue No.	95
LM End	2.42	Issue Type +	En	Location *	LS
Category	Earthen Levee			GPS Latitude/Longitude	
				Start	End
Item	Vegetation			38.471057 °	38.471057 °
				-121.508409 °	-121.508409 °
DWR ID	DWR_RD0307_01_f_2017_95				
Comment Code					
V6 : Landscaping					
Inspector Comment					
Remove cactus to allow inspection and access.

Remove cactus to allow inspection and access. Fall 2017

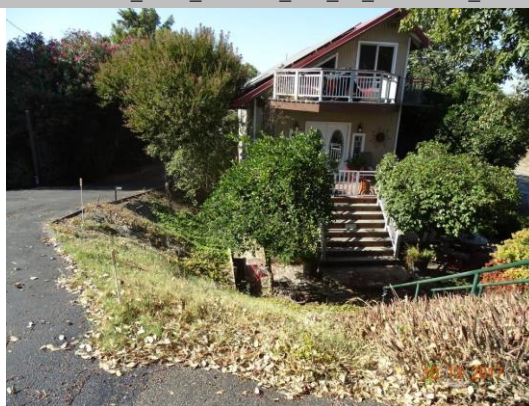
Photo 1 of 1 : SP_2019_RD0307_166_96_20190307_00027.jpg

LM Start	2.59	Rating **	M	Issue No.	96
LM End	2.59	Issue Type +	En	Location *	LS
Category	Earthen Levee			GPS Latitude/Longitude	
				Start	End
Item	Encroachments			38.469358 °	38.469358 °
				-121.506362 °	-121.506362 °
DWR ID	DWR_RD0307_01_f_2017_96				
Comment Code					
TR : Tree or limb					
Inspector Comment					
Remove fruit tree.

Remove fruit tree. Fall 2017

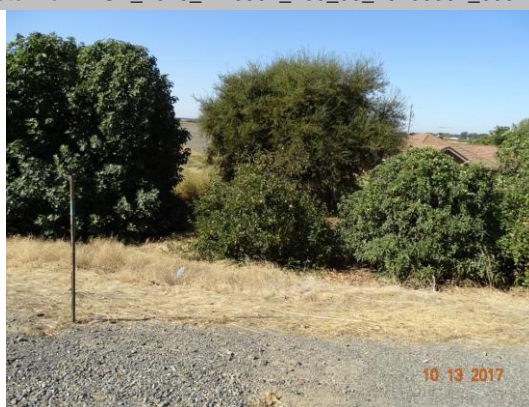
Photo 1 of 1 : SP_2019_RD0307_166_98_20190307_00028.jpg

LM Start	2.64	Rating **	M	Issue No.	98
LM End	2.64	Issue Type +	En	Location *	LS
Category	Earthen Levee			GPS Latitude/Longitude	
				Start	End
Item	Encroachments			38.468547 °	38.468547 °
				-121.506027 °	-121.506027 °
DWR ID	DWR_RD0307_01_f_2017_98				
Comment Code					
TR : Tree or limb					
Inspector Comment					
Remove fruit trees.

Remove fruit trees. Fall 2017

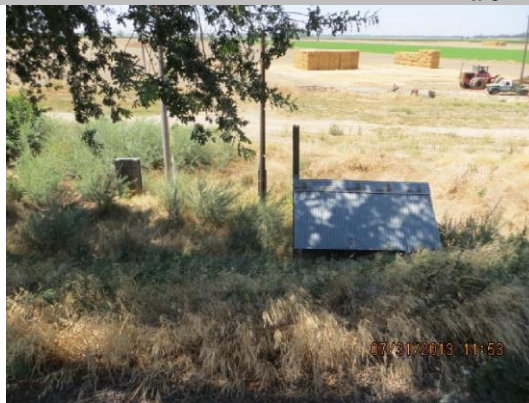
Photo 1 of 2 : UCIP_SP_2019_16815_28850.jpg

LM Start	2.73	Rating **	M	Issue No.	170 (cont)
LM End	2.73	Issue Type +	En	Location *

Pumphouse on LS toe.

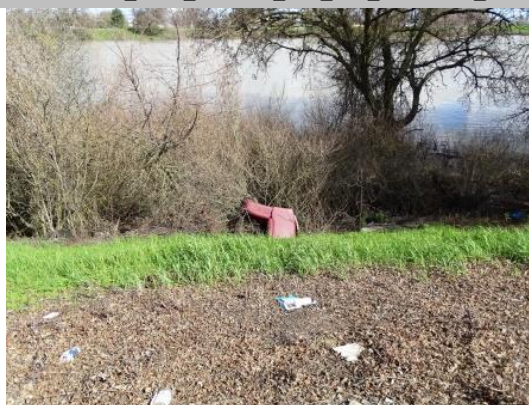
Photo 1 of 2 : SP_2019_RD0307_166_145_20190312_00127.jpg

LM Start	3.09	Rating **	M	Issue No.	145
LM End	3.09	Issue Type +	Ma	Location *	WS
Category	Earthen Levee			GPS Latitude/Longitude	
				Start	End
Item	Encroachments			38.462168 °	38.462168 °
				-121.504988 °	-121.504988 °
DWR ID	DWR_RD0307_01_s_2019_145				
Comment Code					
DE : Debris					
Inspector Comment					
Sofa and other debris need to be cleared from levee slope.

View of sofa dumped on levee slope. Spring 2019

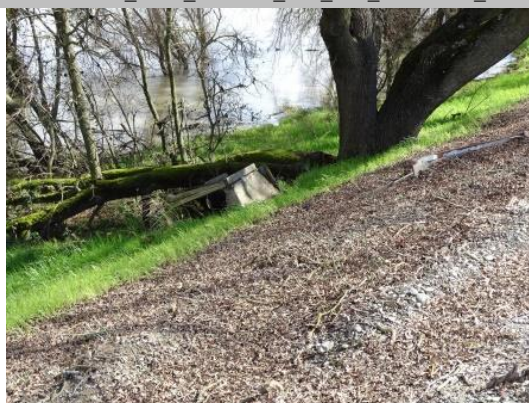
Photo 2 of 2 : SP_2019_RD0307_166_145_20190312_00128.jpg

LM Start	3.09	Rating **	M	Issue No.	145 (cont)
LM End	3.09	Issue Type +	Ma	Location *	WS

View of fallen tree and debris on levee slope. Spring 2019

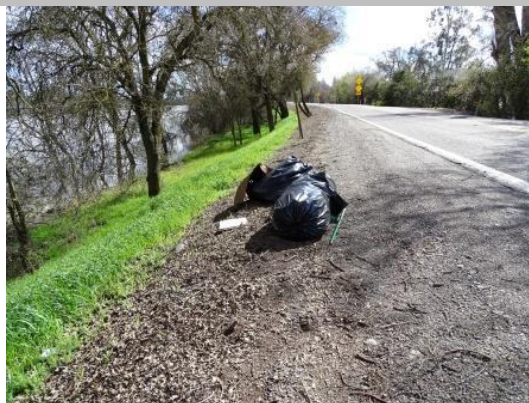
Photo 1 of 2 : SP_2019_RD0307_166_143_20190312_00125.jpg

LM Start	3.38	Rating **	M	Issue No.	143
LM End	3.38	Issue Type +	Ma	Location *	WS
Category	Earthen Levee			GPS Latitude/Longitude	
				Start	End
Item	Encroachments			38.458060 °	38.458060 °
				-121.503978 °	-121.503978 °
DWR ID	DWR_RD0307_01_s_2019_143				
Comment Code					
DE : Debris					
Inspector Comment					
Auto debris and garbage on levee slope need to be cleared.

View of trash dumped on levee slope. Spring 2019

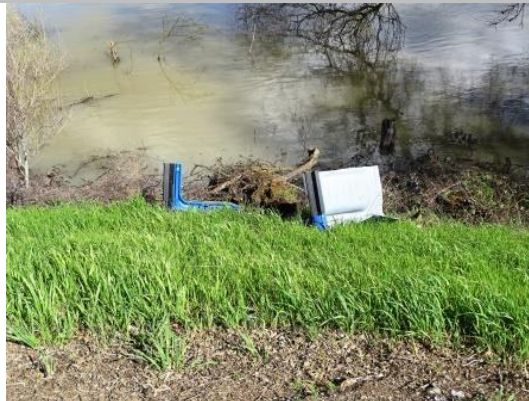
Photo 2 of 2 : SP_2019_RD0307_166_143_20190312_00126.jpg

LM Start	3.38	Rating **	M	Issue No.	143 (cont)
LM End	3.38	Issue Type +	Ma	Location *	WS

View of auto debris on levee slope. Spring 2019

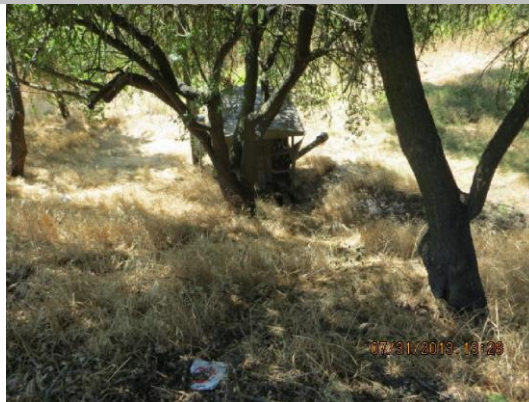
Photo 2 of 3 : UCIP_SP_2019_16923_28977.jpg

LM Start	3.60	Rating **	M	Issue No.	172 (cont)
LM End	3.60	Issue Type +	En	Location *

Pumphouse on LS toe.

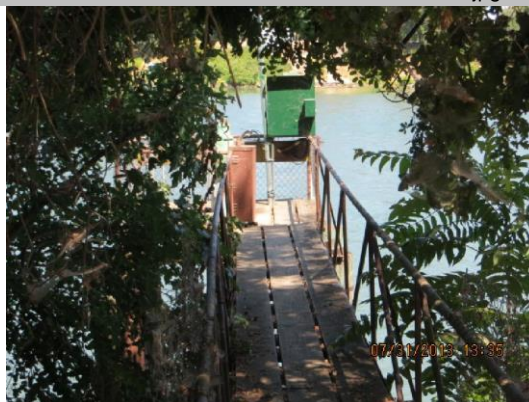
Photo 2 of 3 : UCIP_SP_2019_16924_28981.jpg

Pump and electrical controls on Pier at WS slope.

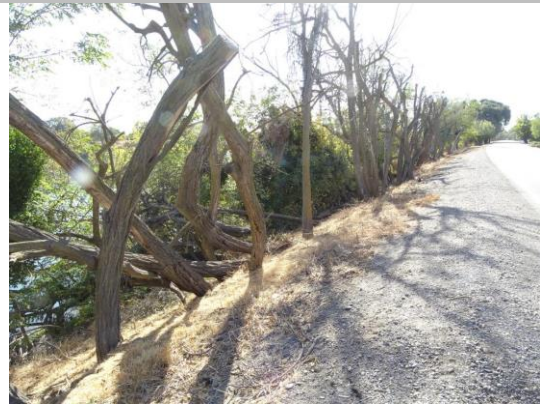
Photo 1 of 1 : SP_2019_RD0307_166_24_20190307_00004.jpg

LM Start	3.86	Rating **	M	Issue No.	24
LM End	3.86	Issue Type +	Ma	Location *	WS
Category	Earthen Levee			GPS Latitude/Longitude	
				Start	End
Item	Encroachments			38.451123 °	38.451123 °
				-121.502622 °	-121.502622 °
DWR ID	DWR_RD0307_01_f_2014_24				
Comment Code					
TR : Tree or limb					
Inspector Comment					
Remove the cut tree limbs from the waterside shoulder.

View of tree limbs on levee slope. Fall 2018

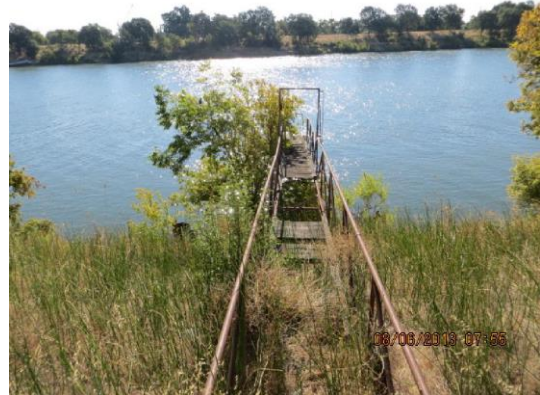
Photo 1 of 3 : UCIP_SP_2019_53338_29022.jpg

FS_ID:53338
DS_ID:21682
EP_NO: 8034
Repair Type: Non-Urgent
Crossing Status: Found
UCIP Comments: 06/05/2018 Same as last inspection, Abandoned. Officially downgrading to Non-Urgent (D. Sanoski - DWR UCIP). 12/07/2016 Crossing has been downgraded from Urgent to Non-Urgent pipe appears abandoned. Need to coordinate with owner to determine status of crossing. If crossing is abandoned, owner will need to coordinate with the CVFPB to comply with Title 23. (O. Magana - DWR UCIP) 08/06/2013 Appears abandoned and should be done so properly. Walkway to pier is falling apart and is an attractive nuisance. Pipe rusted through at riser on LS toe. (W. Wylie - DWR UCIP)
FIELD_STRUCT_DESC: *ABANDONED* 1 of 2: 14-inch steel irrigation pipe through the levee, 13 feet below the crown. Pump on pile structure with walkway located on waterside (WS) slope. Gate valve located on the WS toe and a 48-inch concrete standpipe located on the LS toe. Sheet pile wall around base of metal pier at WS toe (14-inch pipe first referenced in the USACE O&M Manual and later pipe authorized under Automatic Board Order (ABO) issued as Permit No. 8034, 1972 - Heringer). [Additional Reference(s): DWR Levee Log, 1990. USACE Sacramento O&M Manual Unit 114, October 1964 (River Mile 45.67)].

Metal walkway to pump on pier and gate valve actuator on WS slope.

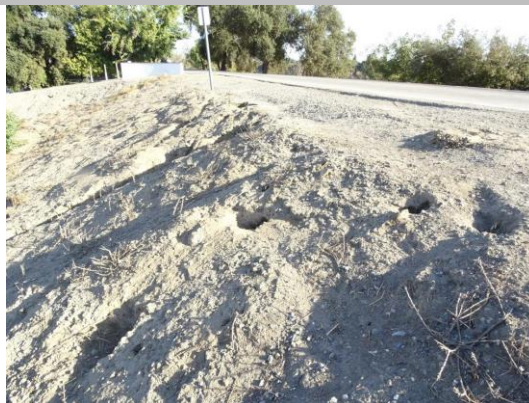
Photo 1 of 1 : SP_2019_RD0307_166_111_20190307_00033.jpg

LM Start	3.96	Rating **	M	Issue No.	111
LM End	3.96	Issue Type +	Ma	Location *	LS
Category	Earthen Levee			GPS Latitude/Longitude	
				Start	End
Item	Animal Control			38.449688 °	38.449688 °
				-121.502646 °	-121.502646 °
DWR ID	DWR_RD0307_01_f_2017_111				
Comment Code					
A1 : Exterminate rodents and backfill and compact or grout burrows.					
Inspector Comment

View of rodent holes on landside slope. Fall 2018

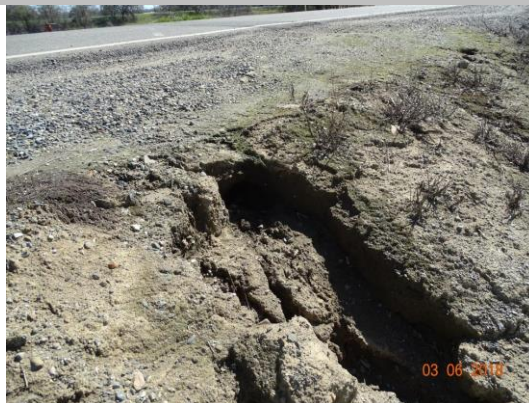
Photo 2 of 3 : SP_2019_RD0307_166_128_20190307_00037.jpg

LM Start	3.98	Rating **	M	Issue No.	128
LM End	3.98	Issue Type +	Ma	Location *	LS
Category	Earthen Levee			GPS Latitude/Longitude	
				Start	End
Item	Erosion / Bank Caving			38.449404 °	38.449404 °
				-121.502663 °	-121.502663 °
DWR ID	DWR_RD0307_01_s_2018_128				
Comment Code					
E1 : Note and monitor erosion site.					
Inspector Comment					
Repair rills on landside slope. Additionally, repair rodent holes along this stretch.

Erosion rodent hole landside looking east. Spring 2018

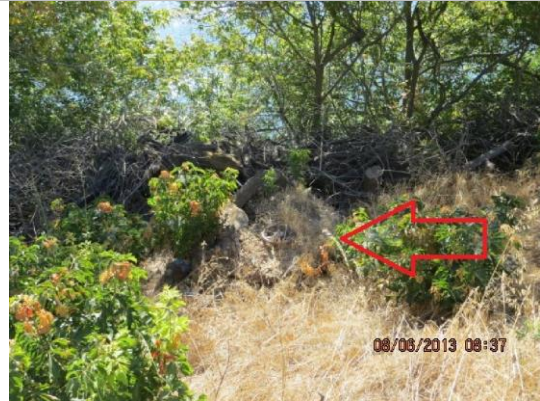
Photo 1 of 3 : UCIP_SP_2019_53339_29261.jpg

Comment Code					
Inspector Comment					
FS_ID:53339 DS_ID:21684 EP_NO: 8038 Repair Type: Non-Urgent Crossing Status: Found UCIP Comments: 06/05/2018 Same as last inspection; appears abandoned and is being downgraded to Non-Urgent from Urgent because no integrity issues were observed during inspection (D. Sanoski - DWR UCIP).12/07/2016 same as last inspection. Need to coordinate with owner to determine pipe status. If crossing is abandoned, owner will need to coordinate with the CVFPB to comply with Title 23. (O. Magana - DWR UCIP)07/31/2013 Wooden lid on 5-foot Diam. CMP riser rotten and could collapse. This could create a hazard for the public and should be replaced. Pipe appears abandoned and should be done so properly. (W. Wylie - DWR UCIP) FIELD_STRUCT_DESC: 6-inch steel irrigation pipe through the levee, 13.5 feet below the crown. Gate valve in 5-foot diameter corrugated metal pipe (CMP) riser located on the waterside (WS) slope. Power pole and meter located on the landside (LS) toe (6-inch pipe first referenced in the USACE O&M Manual and later pipe authorized under Automatic Board Order (ABO) issued as Permit No. 8038, 1972 - King). [Additional Reference(s): DWR Levee Log, 1990. USACE Sacramento O&M Manual Unit 114, October 1964 (River Mile 45.59)]. FS Date: 6/5/2018 10:41:00 AM

Wooden lid at gate valve in CMP riser on WS slope.

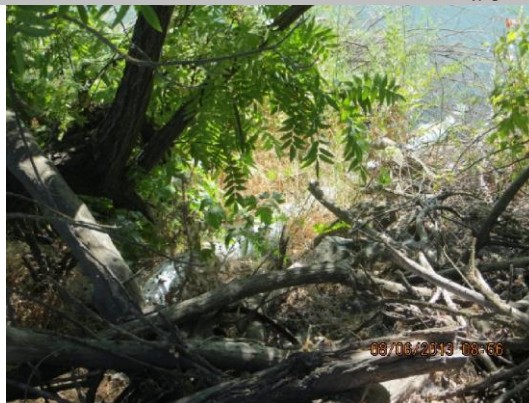
Photo 2 of 3 : UCIP_SP_2019_22670_38289.jpg

Comment Code					
Inspector Comment					
FS_ID:22670 DS_ID:21685 EP_NO: 8039 Repair Type: Non-Urgent Crossing Status: Found UCIP Comments: No lid on CMP riser on WS slope. this could create a hazard for the public. FIELD_STRUCT_DESC: 8-inch steel irrigation pipe through the levee, 12 feet below the crown. Gate valve in a 6-foot-diameter corrugated metal pipe (CMP) riser on the waterside (WS) slope. Pump and gate valve in pump house on the landside (LS) toe. (Permit No. 8039, 1972 - Frederick and Videt Kirtlas and Robert and Hazel Kirtlas). [Additional Reference(s): DWR Levee Log, 1990. USACE Sacramento O&M Manual 114, April 1959, (RM 45.46) (7-inch pipe listed)]. FS Date: 7/31/2013

Pipe visible on WS slope.

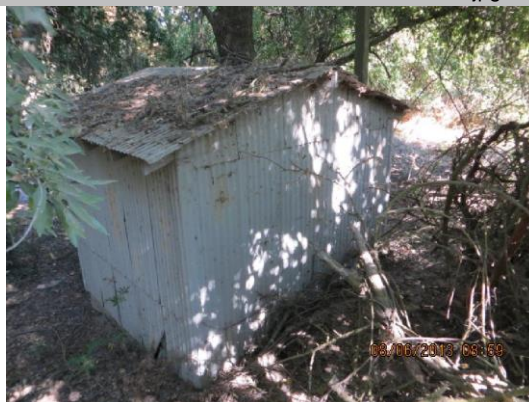
Photo 3 of 3 : UCIP_SP_2019_22670_38292.jpg

Pumphouse on LS toe.

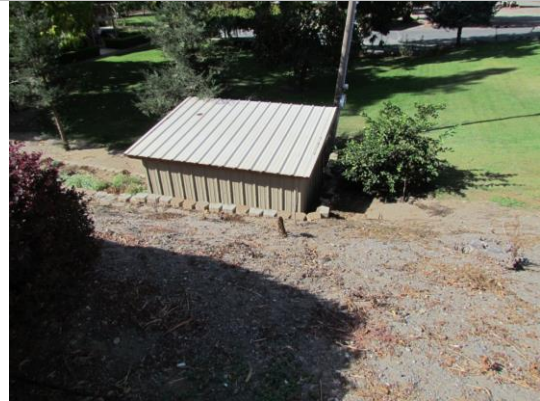
Photo 1 of 1 : SP_2019_RD0307_166_26_20190307_00005.jpg

LM Start	4.31	Rating **	U	Issue No.	26
LM End	4.31	Issue Type +	En	Location *	LS
Category	Earthen Levee			GPS Latitude/Longitude	
				Start	End
Item	Encroachments			38.444612 °	38.444612 °
				-121.503100 °	-121.503100 °
DWR ID	DWR_RD0307_01_f_2014_26				
Comment Code					
BU : Building					
Inspector Comment					
This pumphouse was built without a permit; the district is aware of the encroachment.

This pump house was built without CVFPB Permit.

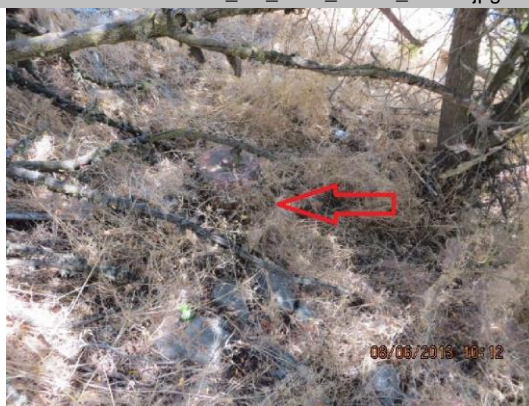
Photo 2 of 3 : UCIP_SP_2019_17183_29320.jpg

Comment Code					
Inspector Comment					
FS_ID:17183 DS_ID:21690 EP_NO: 8041 Repair Type: Non-Urgent Crossing Status: Found UCIP Comments: Pipe appears abandoned and should be done so properly. Gate valve has been removed from pipe on LS toe. FIELD_STRUCT_DESC: 6-inch steel irrigation pipe through the levee, 13.5 feet below the crown. Pump and gate valve in pump house on the landside (LS) slope. Gate valve on the waterside (WS) slope. Service pole and anchor on the LS slope. (Permit No. 8041, 1972 - Albert and Genevieve Fonts). [Additional Reference(s): DWR Levee Log, 1990. USACE Sacramento O&M Manual 114, April 1959, (RM 45.11)]. FS Date: 8/6/2013

Gate valve on WS slope.

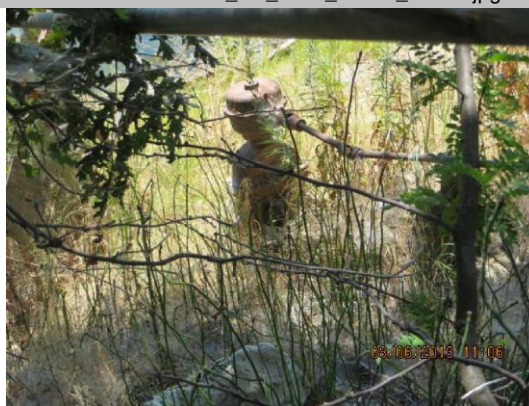
Photo 2 of 3 : UCIP_SP_2019_17184_29325.jpg

Gate valve on WS slope.

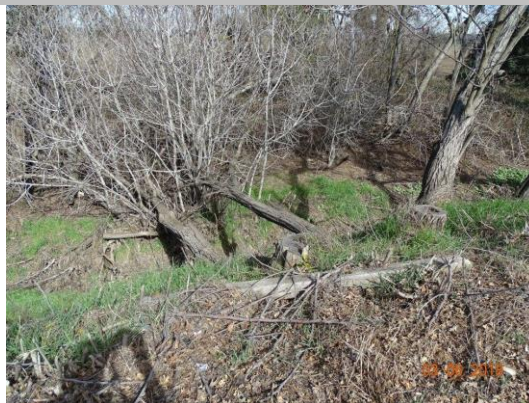
Photo 1 of 1 : SP_2019_RD0307_166_104_20190307_00029.jpg

LM Start	4.88	Rating **	M	Issue No.	104
LM End	4.88	Issue Type +	Ma	Location *	LS
Category	Earthen Levee			GPS Latitude/Longitude	
				Start	End
Item	Encroachments			38.437871 °	38.437871 °
				-121.508356 °	-121.508356 °
DWR ID	DWR_RD0307_01_s_2018_104				
Comment Code					
TR : Tree or limb					
Inspector Comment					
Remove fallen tree from landside slope.

View of fallen tree on landside slope. Spring 2018

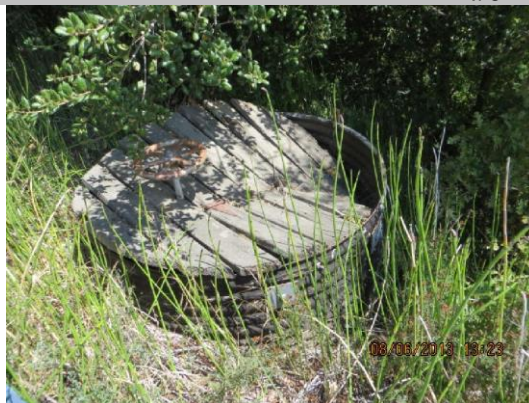
Photo 1 of 3 : UCIP_SP_2019_22710_38415.jpg

Gate valve in 5-foot diameter CMP riser on WS slope.

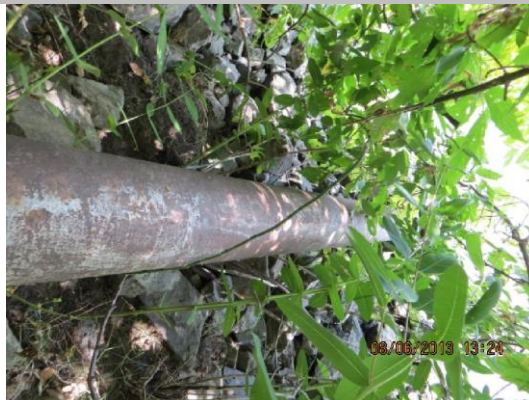
Photo 2 of 3 : UCIP_SP_2019_22710_38414.jpg

Pipe visible on WS slope.

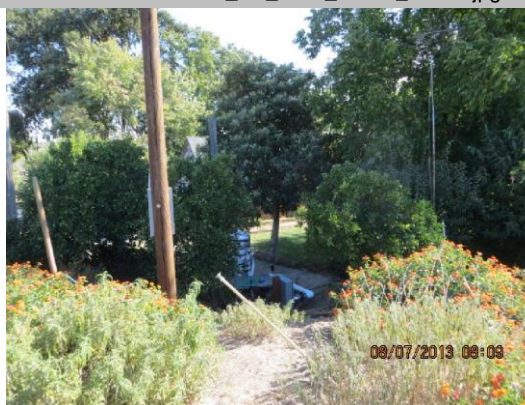
Photo 1 of 3 : UCIP_SP_2019_17287_29423.jpg

Comment Code					
Inspector Comment					
FS_ID:17287 DS_ID:21701 EP_NO: 8050 Repair Type: Non-Urgent Crossing Status: Found UCIP Comments: Lid damaged on 5ft diameter riser on WS slope. Good candidate for video inspection as repair to pipe on LS toe is good indicator that pipe is failing internally. FIELD_STRUCT_DESC: 8-inch steel irrigation pipe through the levee, 12.7 feet below the crown. Pump, vent, butterfly valve, 36-inch concrete standpipe, and a power pole at the landside (LS) toe. Gate valve in a 5-foot-diameter corrugated metal pipe (CMP) riser on the waterside (WS) slope. (Permit No. 8050, 1972 - Glen Franklin Rose). [Additional Reference(s): DWR Levee Log, 1990. USACE Sacramento O&M Manual 114, April 1959, (RM 44.08)]. FS Date: 8/7/2013

Pump and appurtenances on LS toe.

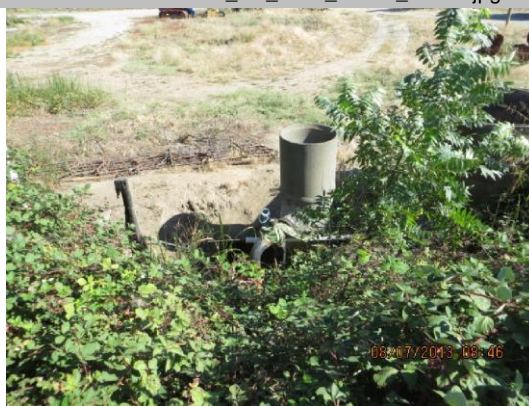
Photo 2 of 3 : UCIP_SP_2019_17343_29441.jpg

Pump, butterfly valve, vent, and concrete standpipe on LS toe.

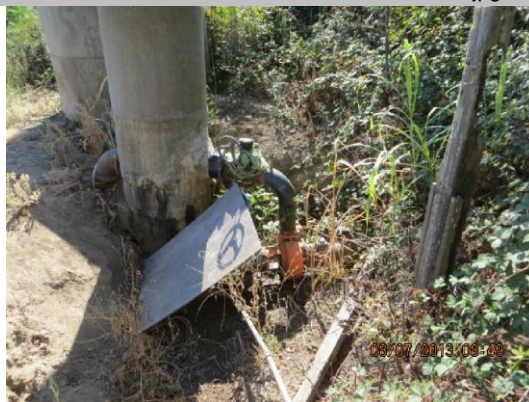
Photo 3 of 3 : UCIP_SP_2019_17343_29440.jpg

Pump, butterfly valve, vent, and concrete standpipe on LS toe. hoto 3 description or comment here.

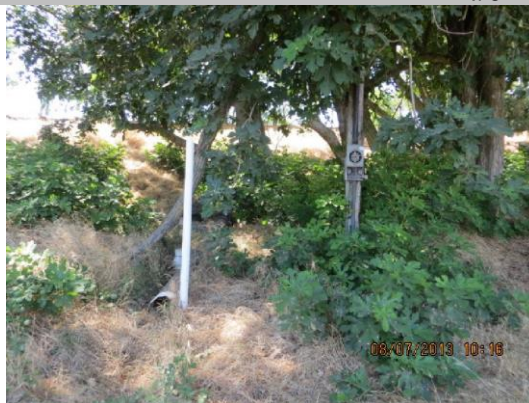
Photo 2 of 3 : UCIP_SP_2019_22712_38421.jpg

Pipe, power pole, and meter on LS toe.

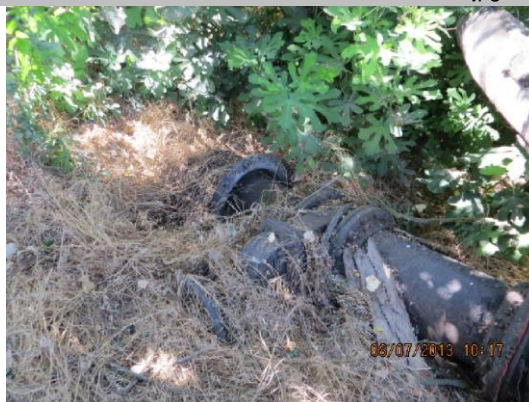
Photo 3 of 3 : UCIP_SP_2019_22712_38420.jpg

Gate valve on LS toe.

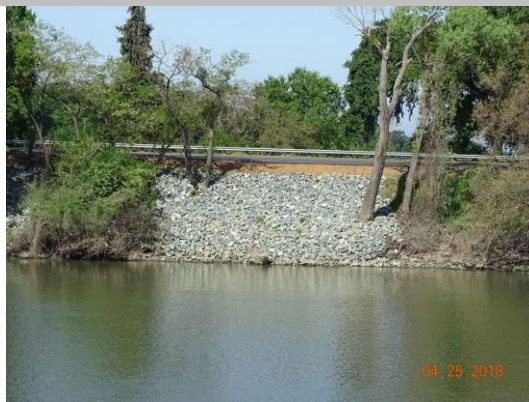
Photo 1 of 2 : SP_2019_RD0307_166_107_20190307_00030.jpg

LM Start	6.42	Rating **	A/W	Issue No.	107
LM End	6.55	Issue Type +	Ma	Location *	WS
Category	Earthen Levee			GPS Latitude/Longitude	
				Start	End
Item	Erosion / Bank Caving			38.431792 °	38.429923 °
				-121.533353 °	-121.533235 °
DWR ID	DWR_RD0307_01_s_2018_107				
Comment Code					
Inspector Comment					
This is to identify corrections to the USACE 2015 Erosion survey. The LMA repaired erosion sites in 2017. Spring 2019 DWR Inspection: Riprap and slope remain intact.

RD307 Lisbon Unit 1 Issue 107 LM6.42-6.55 Erosion repaired picture taken from LB looking west.

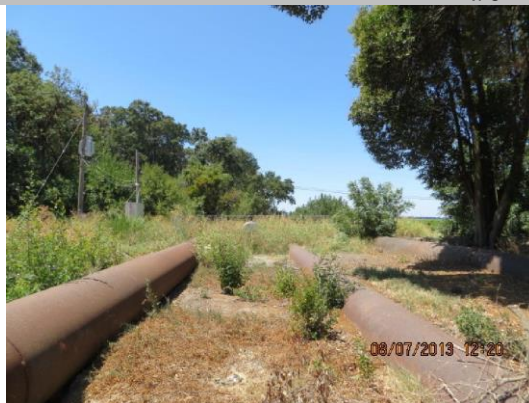
Photo 1 of 3 : UCIP_SP_2019_17404_29504.jpg

Pipe visible on LS toe to pumping plant 200-feet off LS toe.

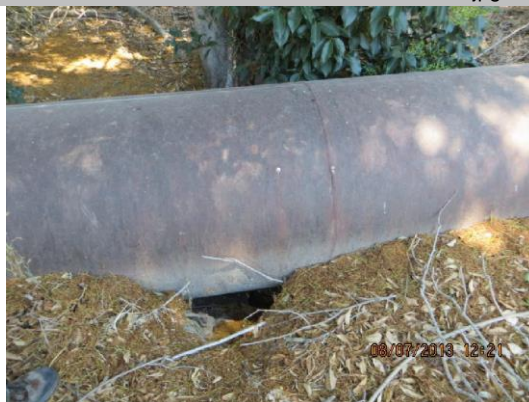
Photo 2 of 3 : UCIP_SP_2019_17404_29503.jpg

Animal activity/burrows under pipe on LS at various locations.

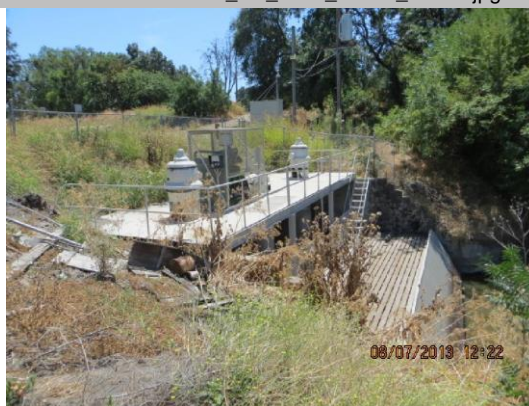
Photo 2 of 3 : UCIP_SP_2019_17406_29509.jpg

Pump and trash rack 200-feet off LS toe.
